## BAILEY SITE REPORT – POST HURRICANE IKE

12 November 2008

Subject: Bailey Site Conditions – Post Hurricane Ike

This report provides a summary of the site conditions at the Bailey Superfund Site following Hurricane Ike.

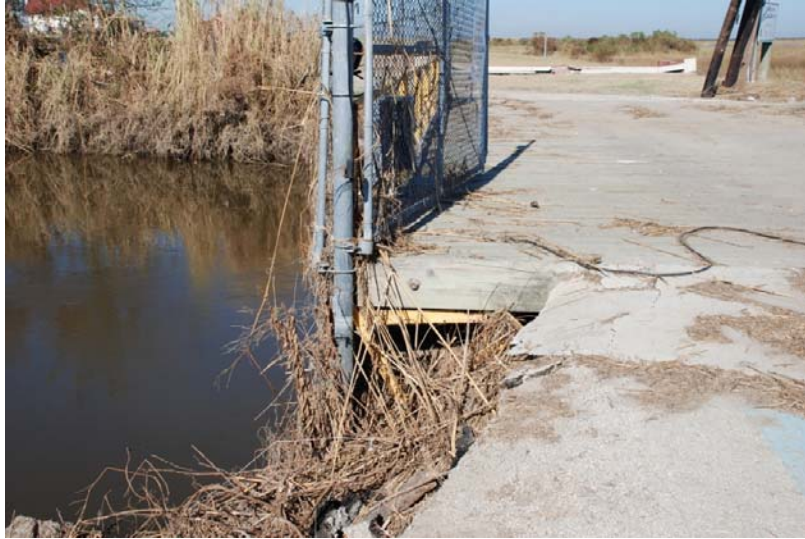
- The access bridge to the property does not appear to have sustained any damage from the storm surge. The road access leading to the outside gate area on the access bridge does have erosion on the south side. The property is still accessible; however, this portion of the access area needs to be monitored for additional erosion that could impact the road-bridge access. See Photo 1 and 2.

Photo 1 – Erosion at access bridge – looking west onto property

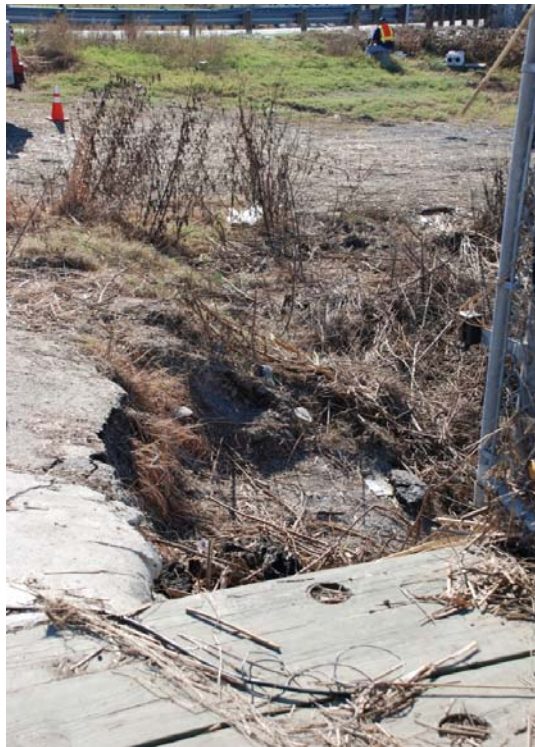
Photo 2 – Erosion at access bridge – looking east towards highway 87

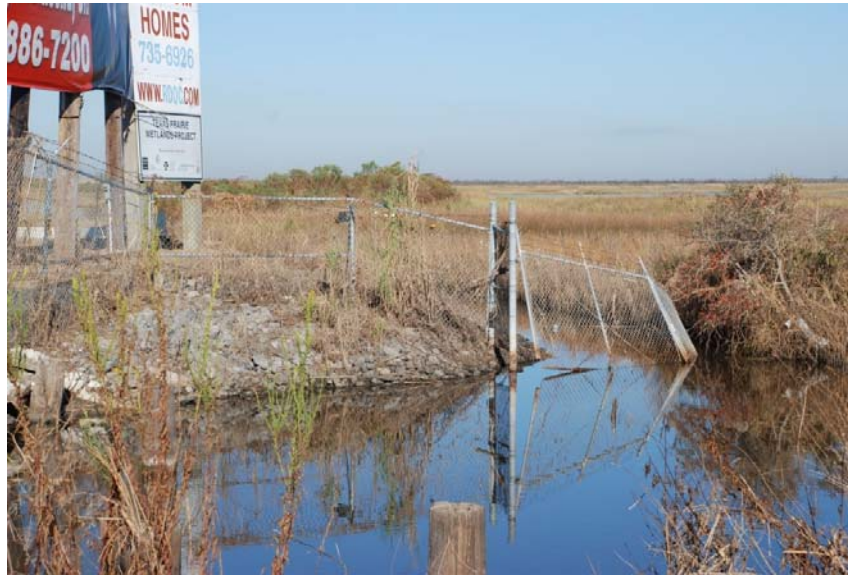
- The chain link fencing and barbed wire on both sides of the access bridge is damaged/down and needs to be repaired/replaced. See Photos 3 and 4.
- The fencing along the East Dike Cap from the access bridge to approximately the third gas vent has been pushed over by the storm surge and needs to be repaired/replaced. The total length of affected fencing to replace is approximately 900 feet. See Photos 5 through 7.

Photo 3 – Fence over channel on north side of access bridge, looking northwest.

- Repair/replace the damaged perimeter fence as noted in this report,
- Repair/replace the damaged and missing signs as noted in this report,
- Remove the debris left by the storm surge, and
- Conduct a land survey on the East Dike Cap. This survey will be compared to the survey conducted in 2005 to calculate the level of settlement on the East Dike Cap, if any.

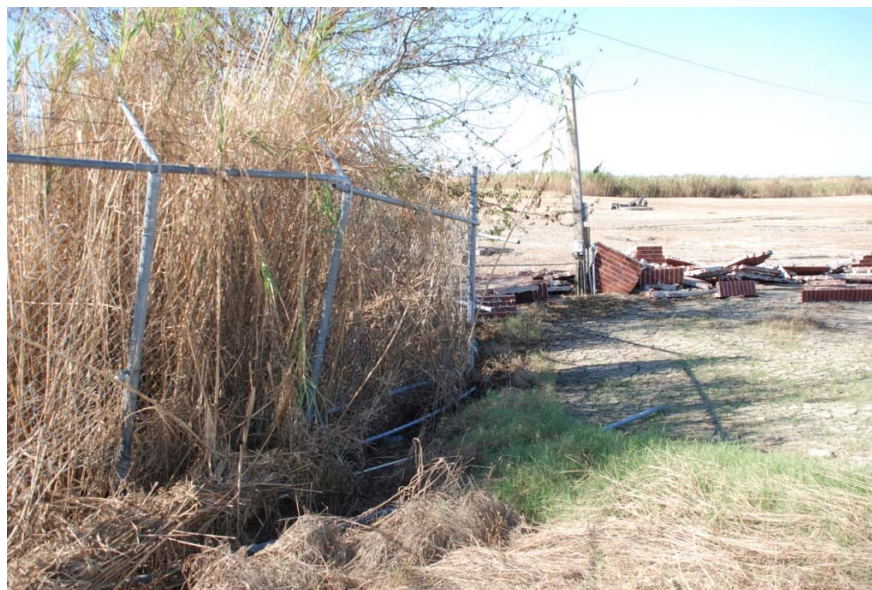
Photo 4 – Fence on south side of access bridge, looking southwest.

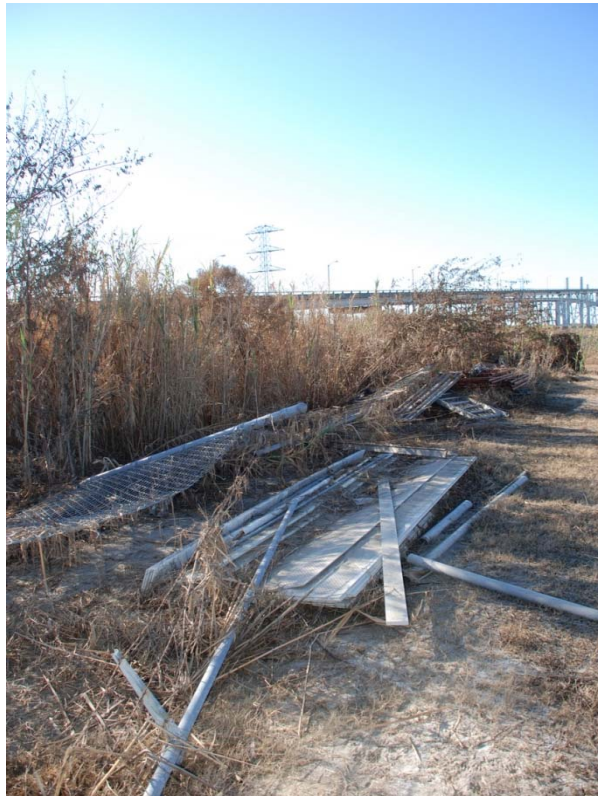
Photo 5 – Fence in laydown area on edge of East Dike Cap, looking south

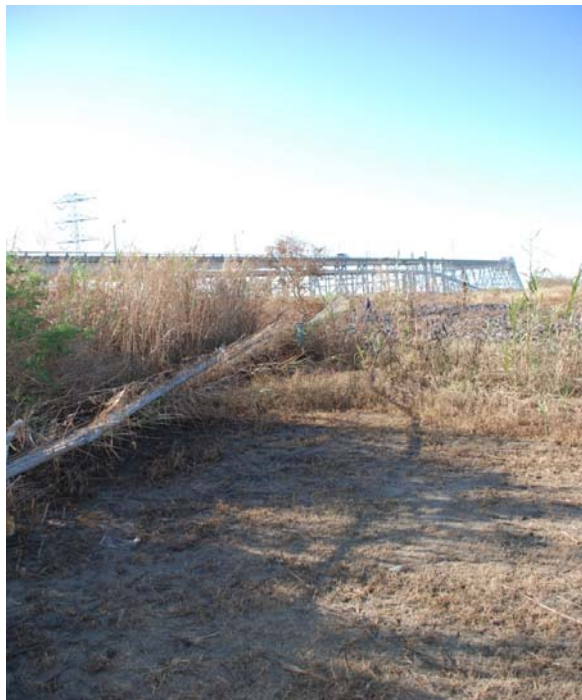
Photo 6 – Fence on East Dike Cap at each of cap area, looking south

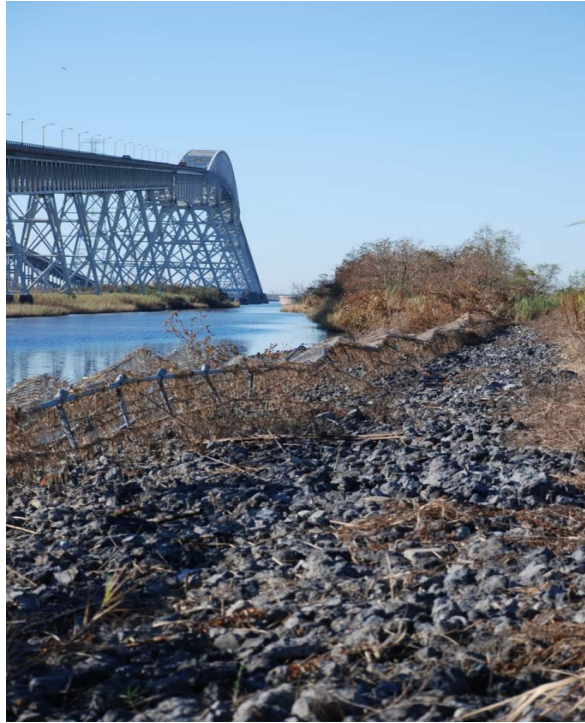
Photo 7 – Fence as shown along East Dike Cap at third gas vent, looking south

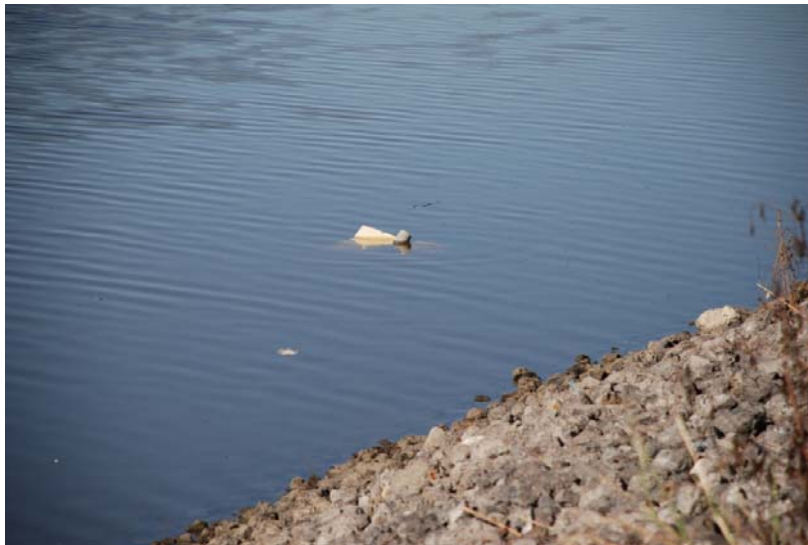
- Select signs located around the perimeter of the property sustained damage. The signs on the East Dike Cap fence are still intact on the fence. There were only two signs missing/damaged along the North Dike Cap. See Photos 8 and 9.

Photo 8 – Sign missing in channel on south side of North Dike Cap

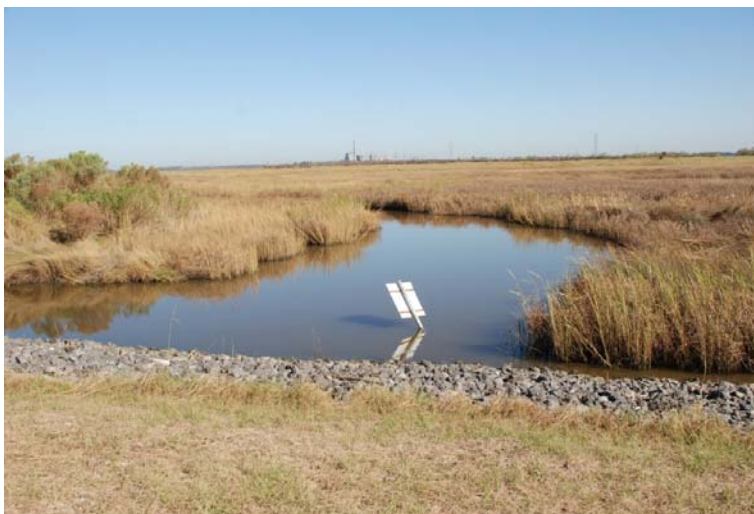
Photo 9 – Sign damaged in channel on north side of North Dike Cap

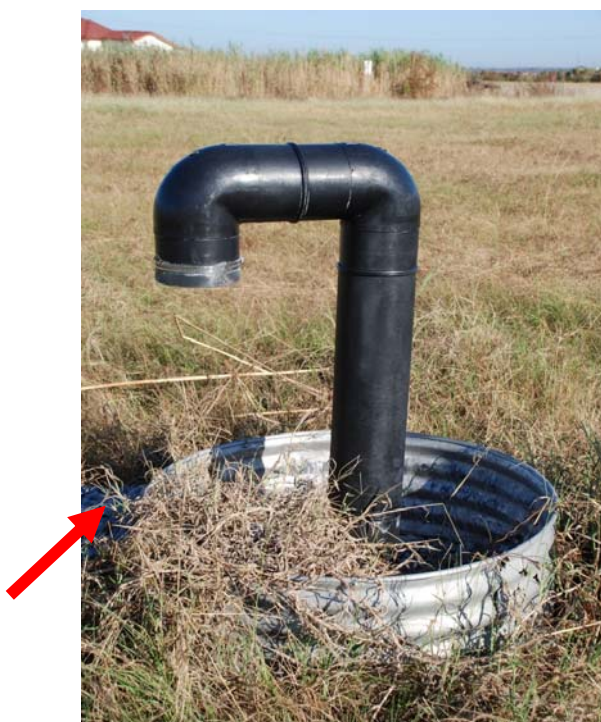
Photo 10 – East Dike Cap Gas Vent – rocks on west side of vent

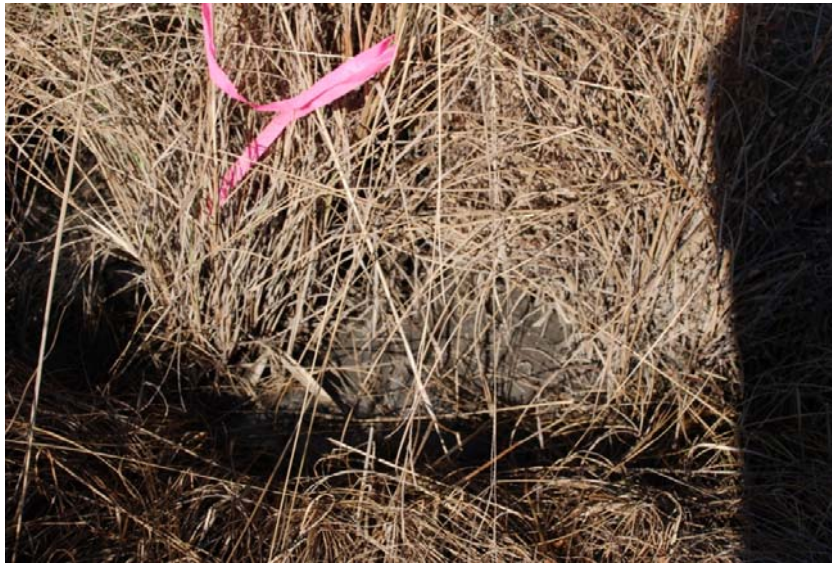
- Due to storm surge, the East Dike Cap did have flood waters over the top of the cap. Per visual appearance of the cap, gas vents, and surrounding property, the water was estimated to be approximately 2-3 feet above the level of the cap.
- All of the gas vents are upright and in good condition. The only damage noticed is the rocks inside the vents have been pushed out onto the cap, due to the surge movement during the storm. See Photo 10.
- The area on the East Dike Cap between the 3<sup>rd</sup> and 4<sup>th</sup> gas vent continues to be an area of concern regarding settlement. Our site visit was conducted approximately two weeks after the hurricane made landfall. The ground in the area between the 3<sup>rd</sup> and 4<sup>th</sup> gas vents was still moist from the flood waters associated from the hurricane. See Photos 11 and 12.

Photo 11 – Saturated soil in area of concern on East Dike Cap

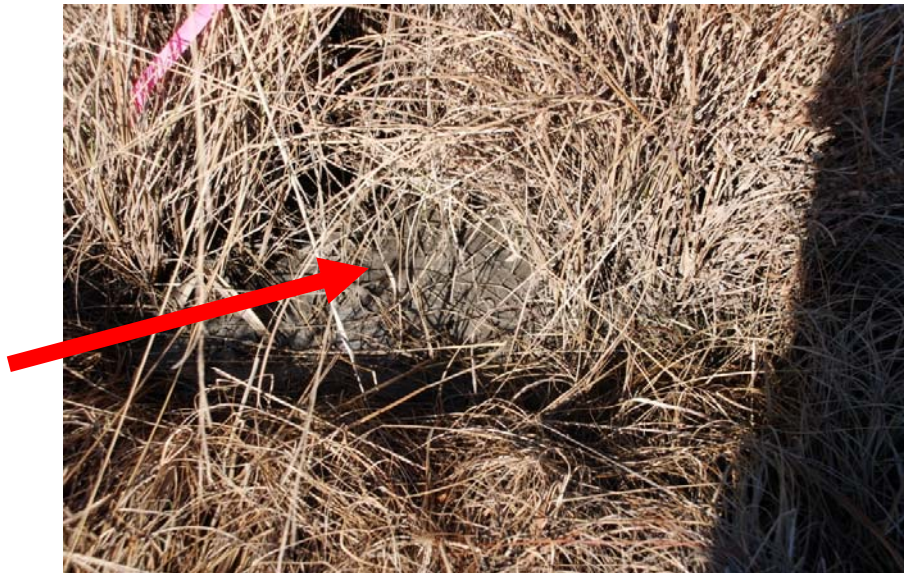
Photo 12 – Another photo of saturated soil between 3<sup>rd</sup> and 4<sup>th</sup> gas vent on East Dike Cap

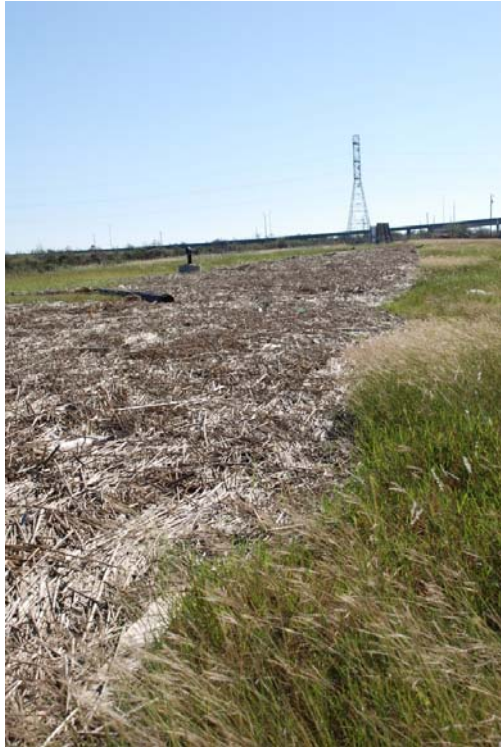
- Due to storm surge, the North Dike Cap did have flood waters over the top of the cap. Per debris left by the movement of the surge, it appears that the North Cap was underwater, but the depth of the flood varied due to the slope of the cap. There is a debris line on the North Dike Cap from approximately the 1<sup>st</sup> gas vent to the 3<sup>rd</sup> gas vent. The debris is mostly hay and vegetative material; however, there are a few large timbers and in the debris. See Photos 13 and 14.

Photo 13 – Debris line on North Dike Cap – looking east

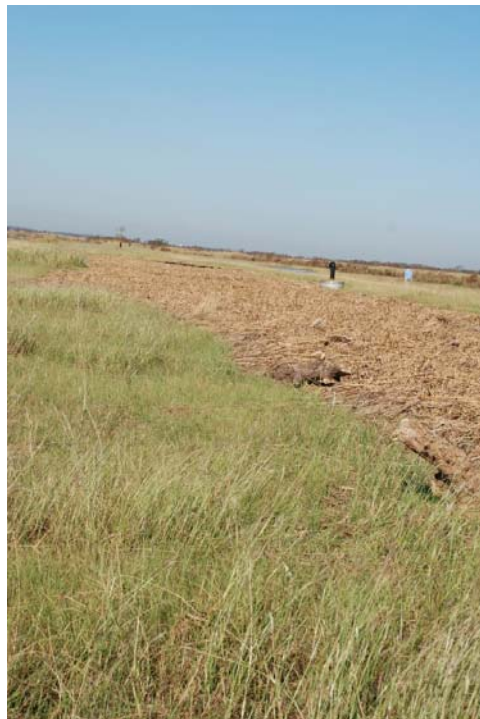
Photo 14 – Debris line on North Dike Cap – looking west

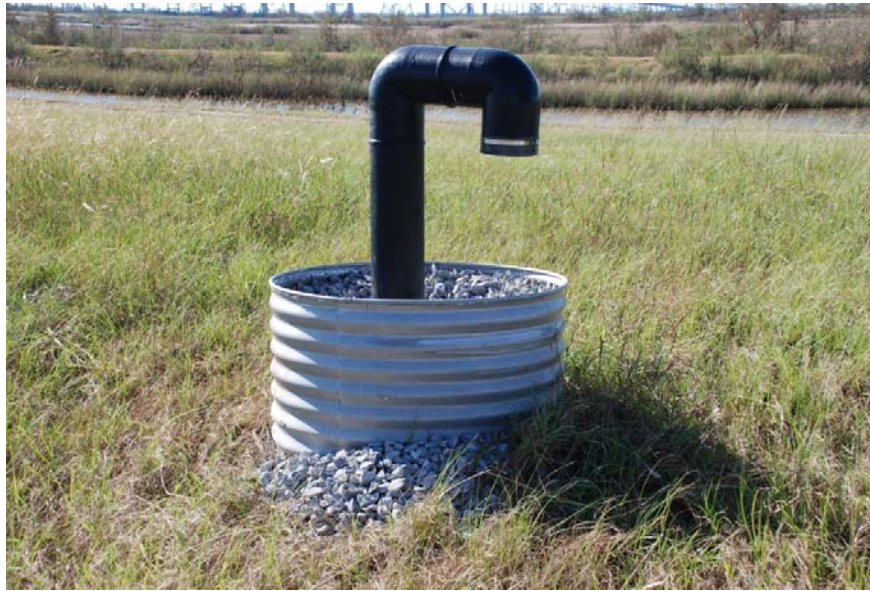
- All of the gas vents are upright and in good condition. The only damage noticed is the rocks inside the vent basins have been pushed out onto the cap, due to the surge movement during the storm, as they were on the East Cap as well. See Photo 15.

Photo 15 – Gas Vent on North Dike Cap – rocks pushed out of vent basin by surge

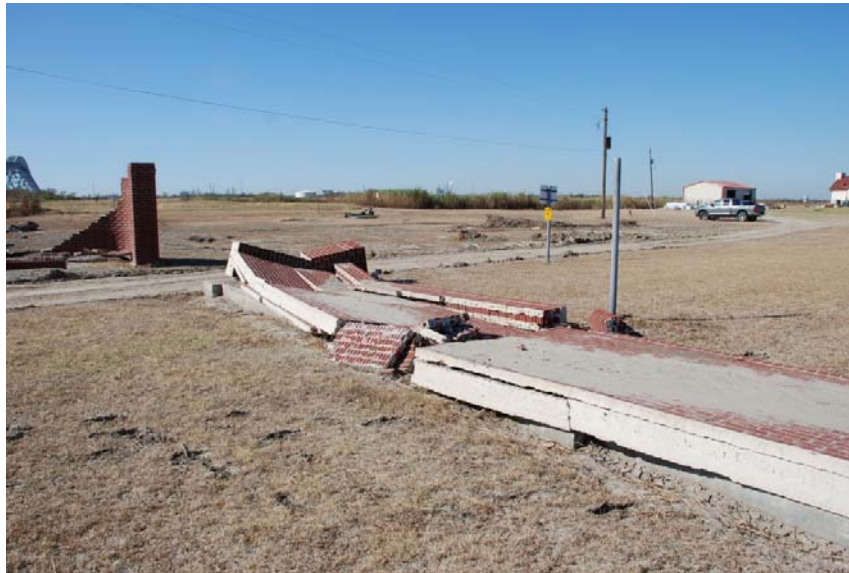
- The brick wall that the property owner built was pushed over by the surge waters. The wall fell towards the eastern edge of the North Dike Cap. The sign located at the edge of the cap is missing. See Photo 16.

Photo 16 – Brick wall and missing cap limit sign on North Dike Cap, looking west-southwest
